# Resolving Cyclic Vibration on an Instrument Air Compressor

## **Case Study on Resolving Cyclic Vibration on an Instrument Air Compressor Train**

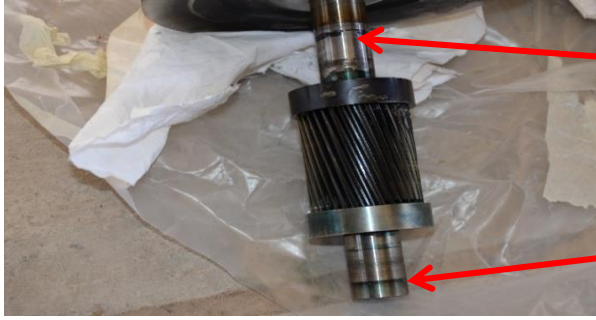
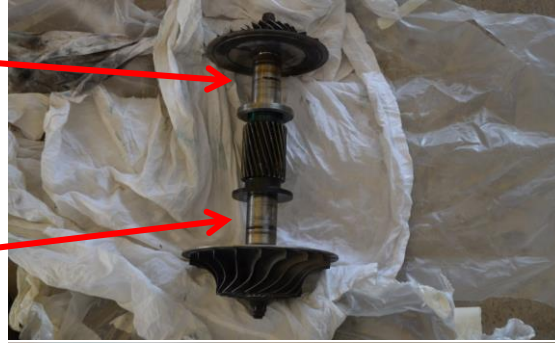
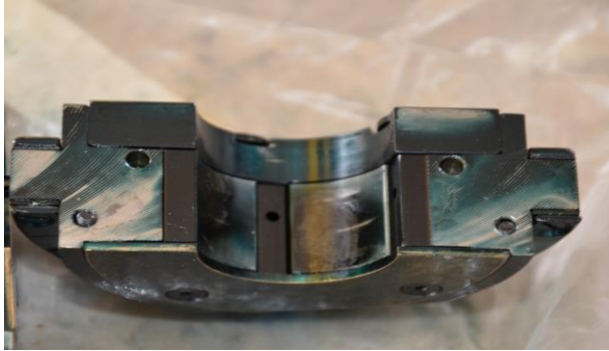
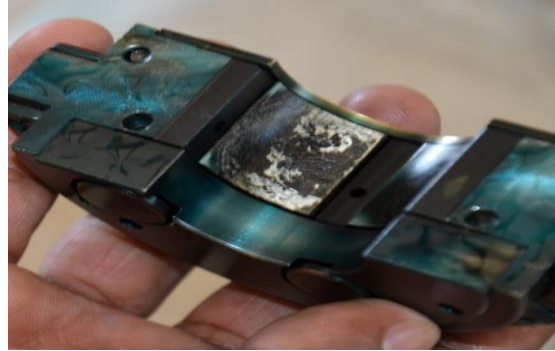
## Machine Inspection Findings

*Brownish oil burn marks on 2<sup>nd</sup> & 3<sup>rd</sup> stage bearings and rubbing marks on the pinion rotors observed.*

- *Carbon Seals rub due to mis-alignment across the gears.*
- *Burnishing is suspected due to shear stresses in the oil causing high temperature.*

- All the pinion rotors were replaced with new rotors.
- All the bearings were replaced.
- Alignment of the integral gear assembly was carried out.
- Lubricating oil was replaced per the recommendation from OEM. The oil type was changed in terms of viscosity (higher to lower viscosity).
